INSPECTION REPORT
U.S. ENVIRONMENTAL PROTECTION AGENCY
REGION IX
WASTE COMPLIANCE SECTION

Purpose: RCRA Compliance Evaluation Inspection

Facility: Westates Carbon - Arizona, Inc.
2523 Mutahar Street
Parker, AZ 85344

Date of Investigation: August 17, 1993

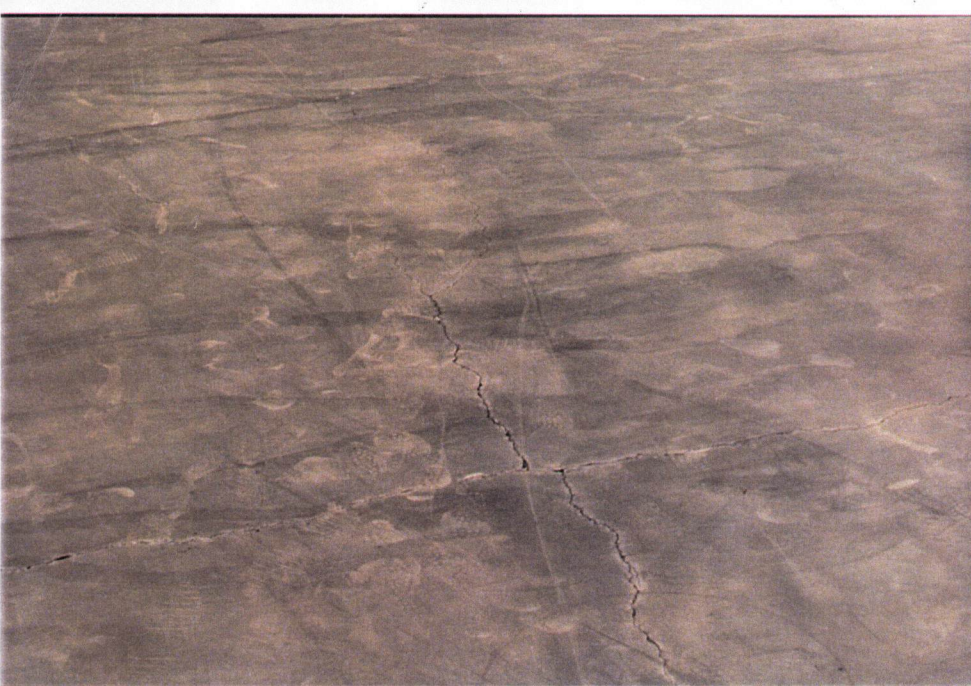
Process Area - Tanks T-1, T-2, T-5, T-6, T-9 and T-12 as well as the furnace are all located in this area. (See photos #17, #18). A concrete pad underlays this area and the pad is sloped and bermed. Numerous cracks were noted in the concrete pad. (See photo #19). I pointed out several cracks to Mr. McCue and he said that they (Westates) do not have a good solution as to how to fill in the cracks. I also noted that the berm is cracked in several spots, though still intact.

#19 - Process Area. Numerous cracks were observed in the concrete underlaying the Process Area.

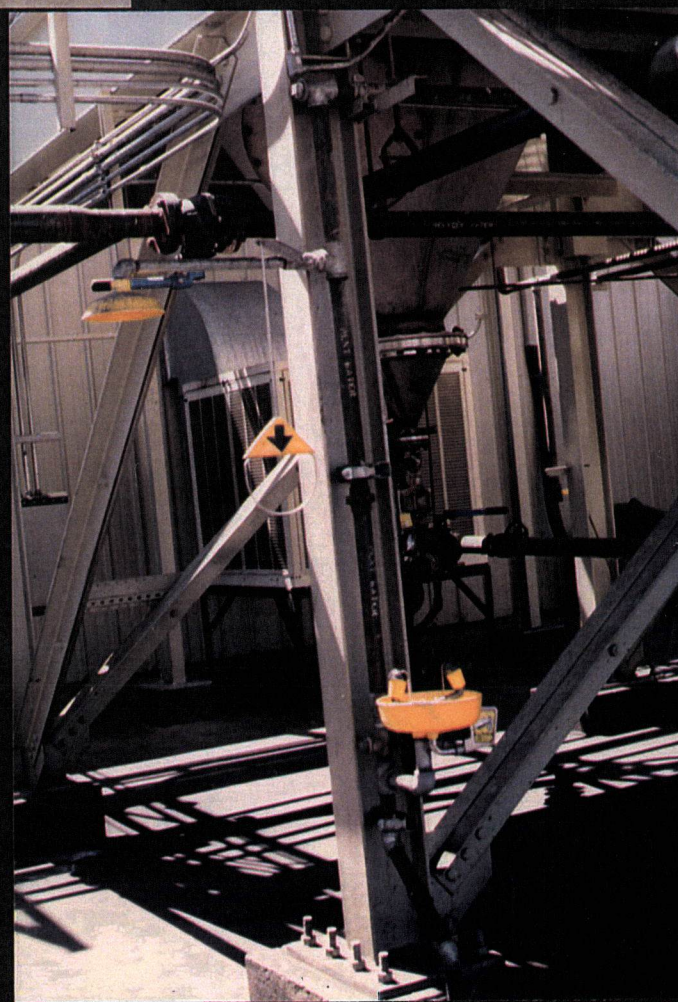
Safety equipment observed in the Process Area included an emergency eyewash/safety shower (photo #20) and a fire alarm and extinguisher (photo #21).

#20 - Process Area. Emergency eyewash and safety shower.

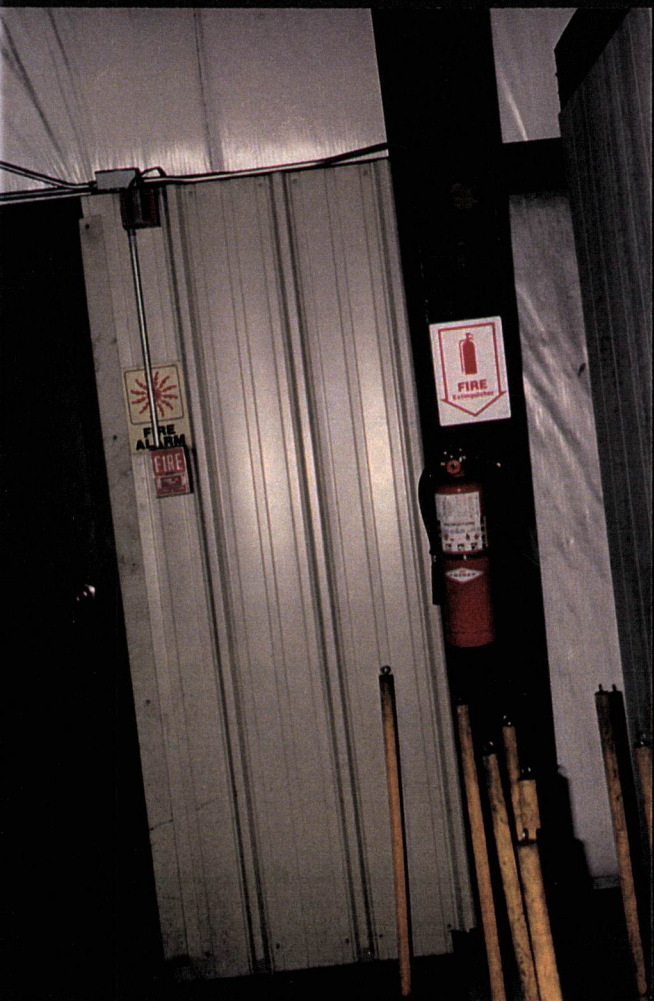
#21 - Process Area. Fire alarm and extinguisher.
